Car has severe misfire.

P0172 System too rich Bank 1

P0174 System too lean Bank 2

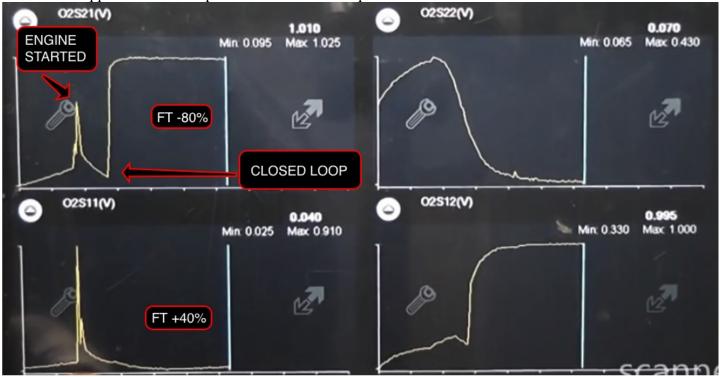
Thats what happens when two upstream O2 sensors are placed in reverse order:

- 1. Car enters into the closed loop. PCM uses O2 signal for delivering the right mixture.
- 2. When PCM tries to add more fuel into bank 1, upstream sensor that is placed on bank 1 PCM sees as B2S1.
- 3. PCM thinks that bank 2 has too much gas, even though in reality its bank 1, and it tries to reduce fuel on bank 2.
- 4. B2S1 sensor, that PCM sees as B1S1, shows too much air and tries to add fuel to bank 1.

Two upstream O2 sensors placed in reverse order.
