Electrical Problems and B-CAN DTCs After Exposure to Water/Water Leaks

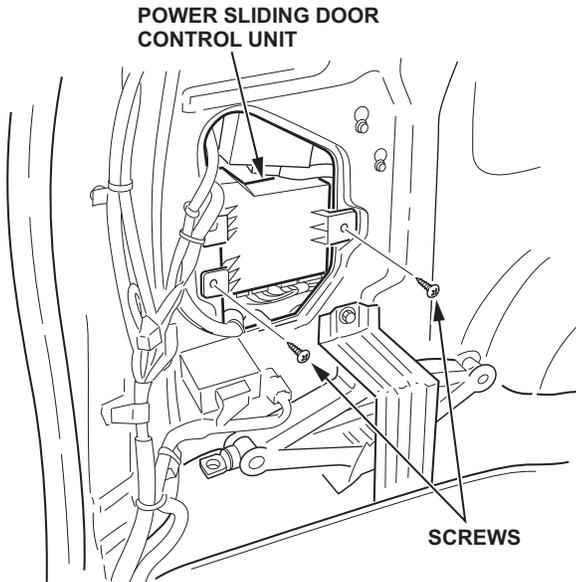
2. If equipped, remove the power sliding door control unit (two screws) to access connector C701 and to view the panel for water leaks.

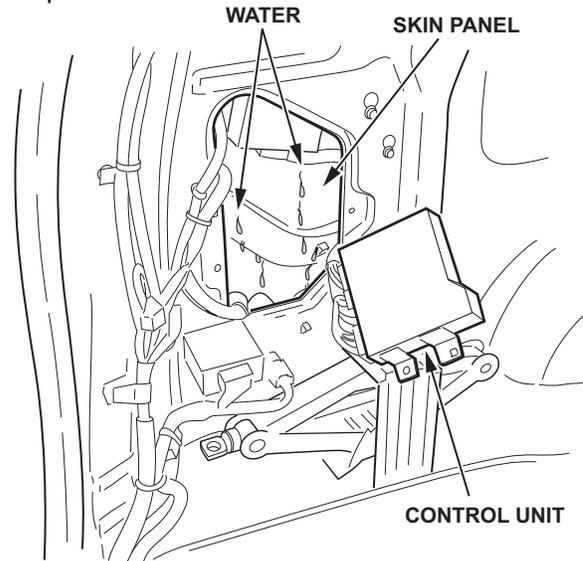
- If only a small amount of water is leaking in, go to step 9.

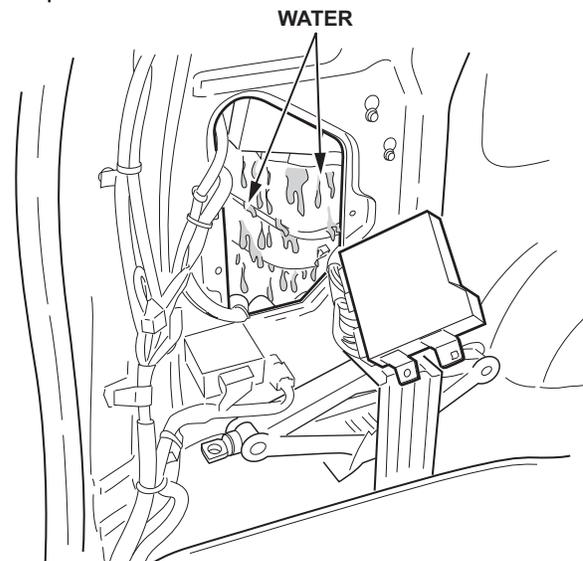
- If a large amount of water is leaking in, go to step 4.

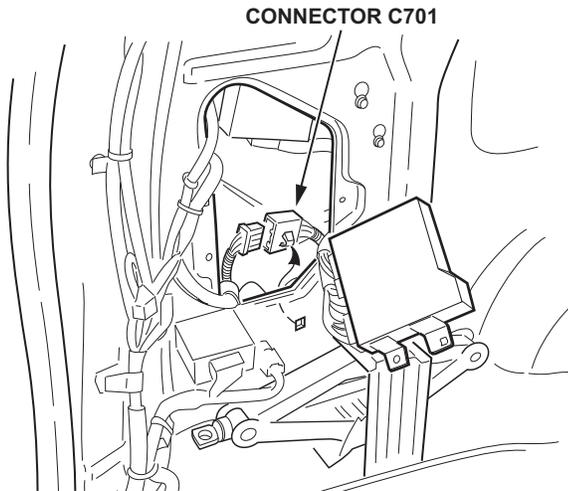
Water enters connector C701 behind the left rear side trim panel.

10. Locate and remove connector C701 from the panel. Disconnect the connector.

NOTE: On Touring models, there are two connectors piggybacked in this location.
