2003 Ford Expedition

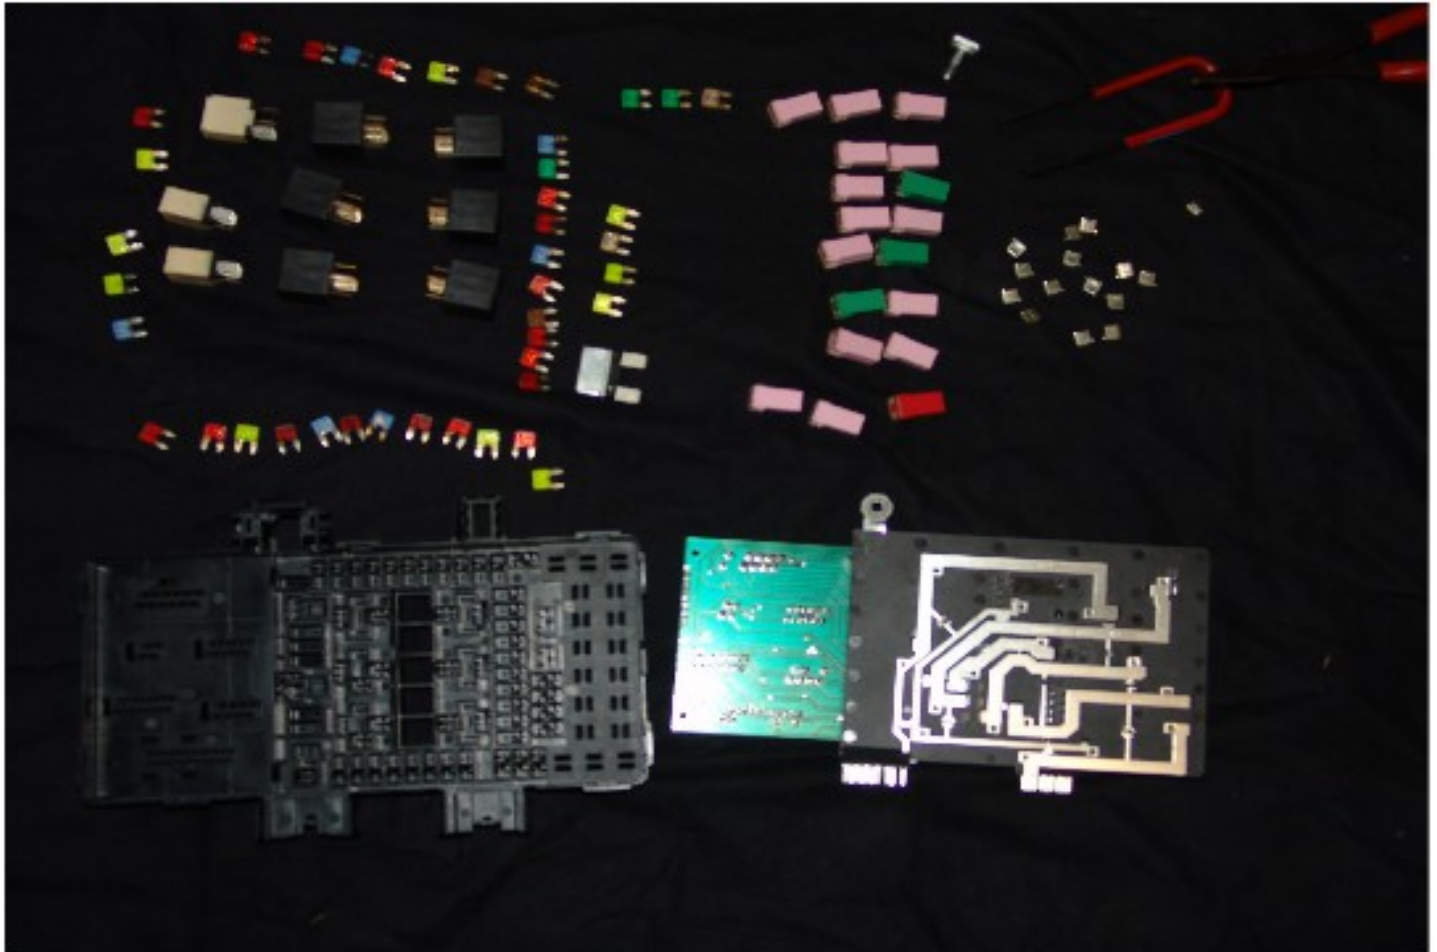
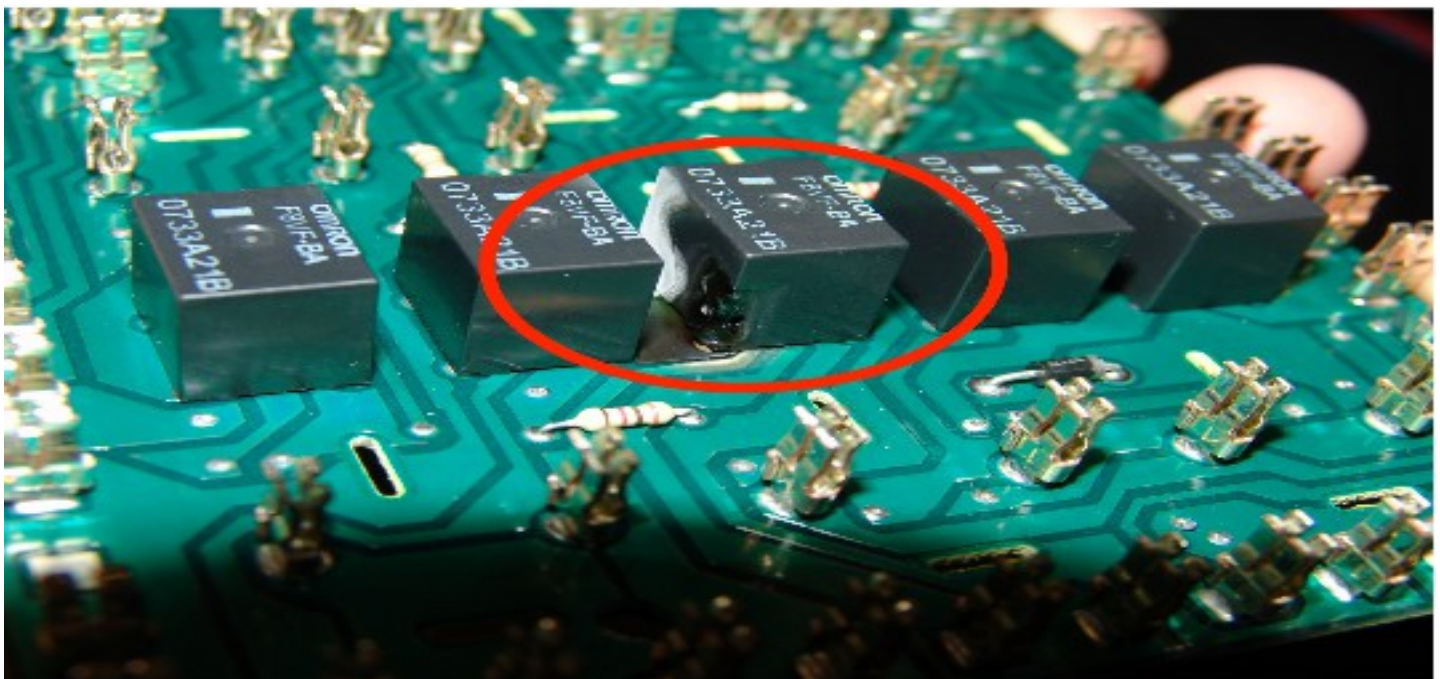
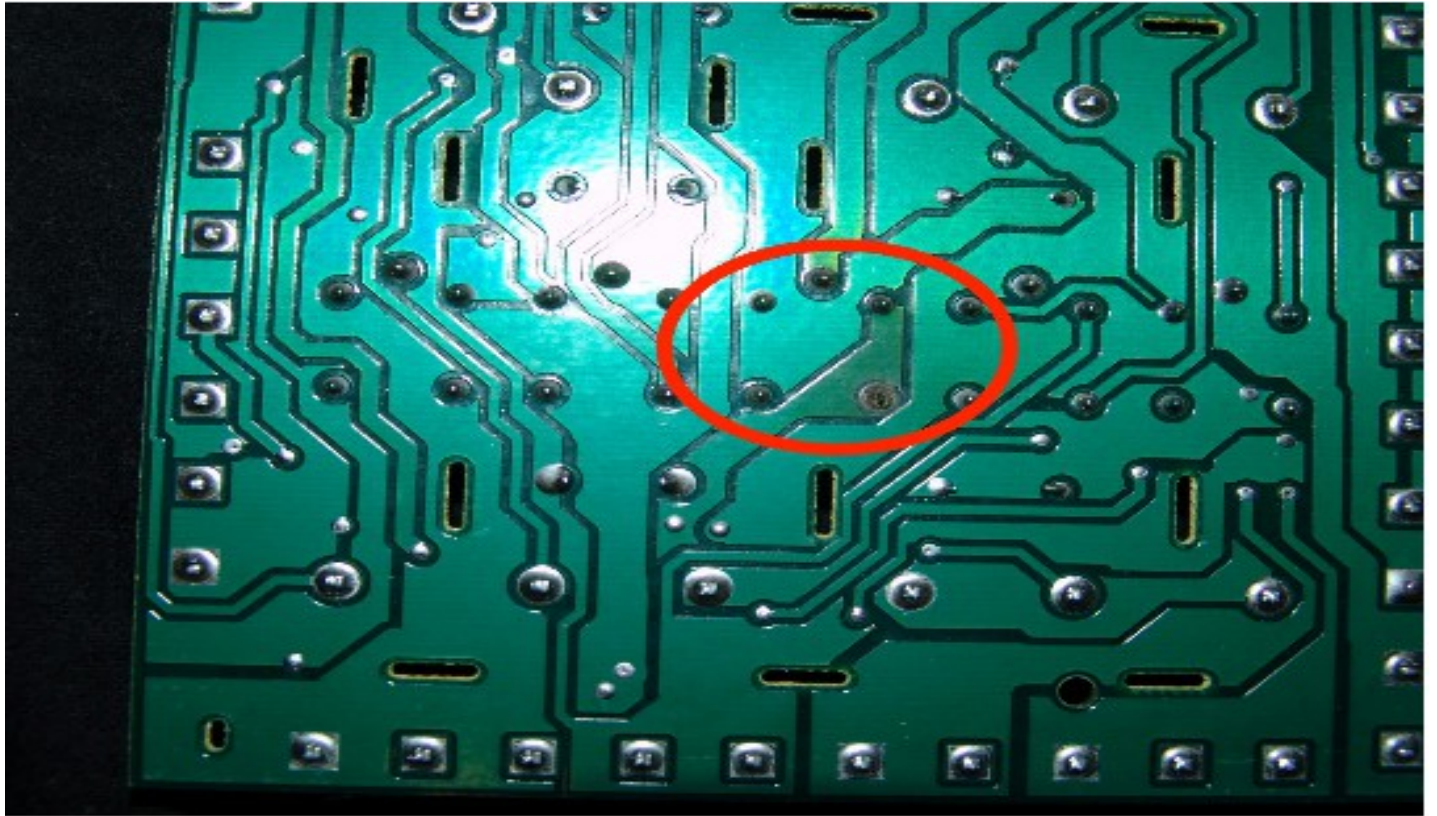
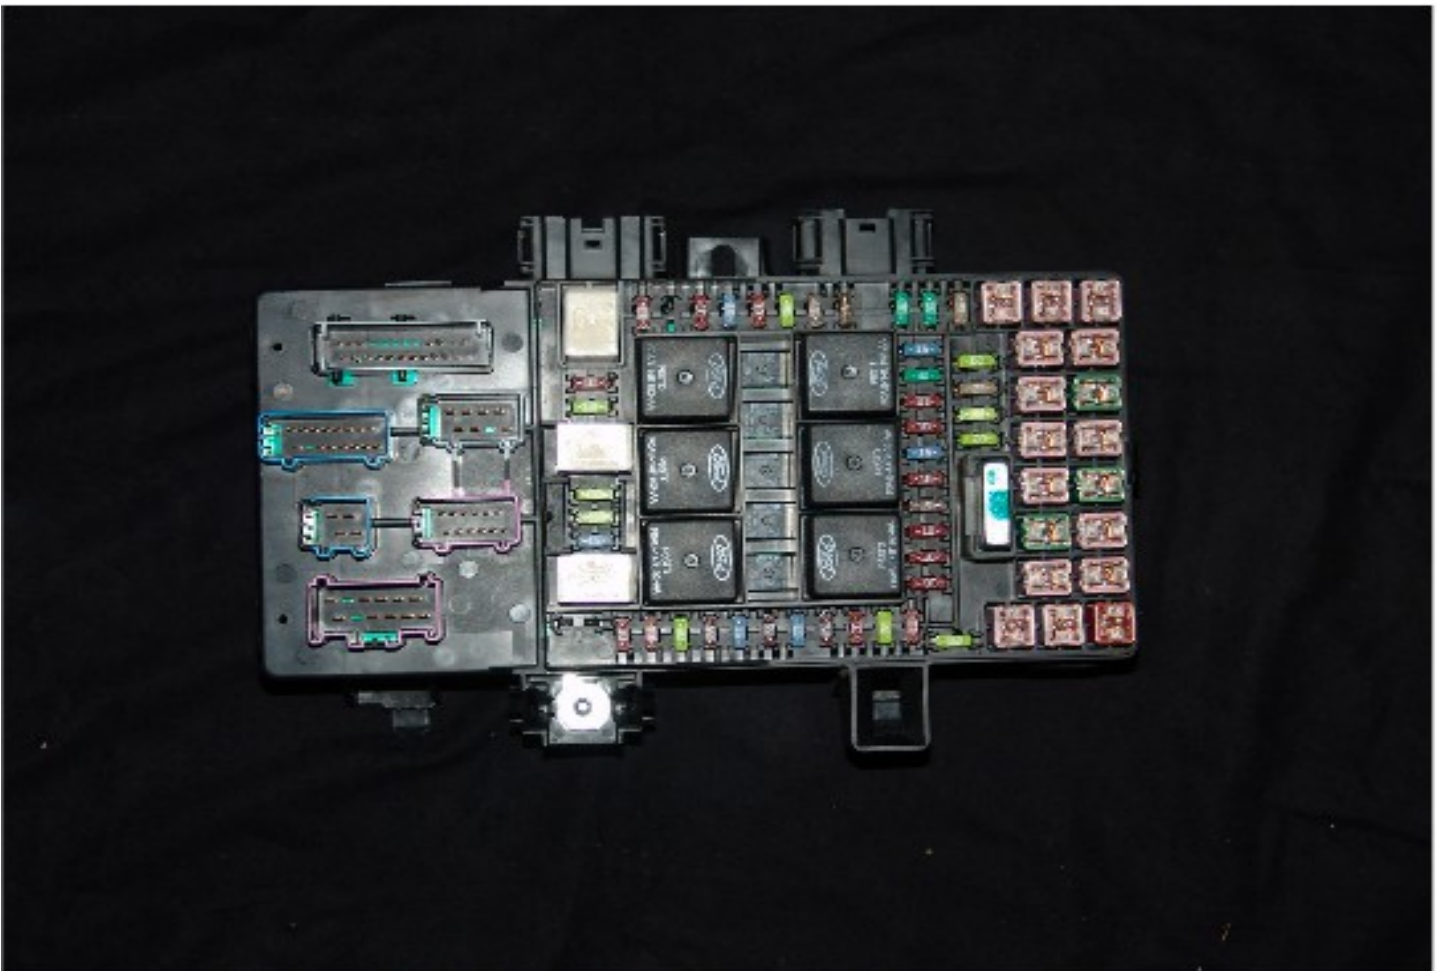
Ford has 5 mini relays soldered to the board INSIDE the fuse panel held to it with the pins sticking through and soldered on the printed board. On this one, one of the pins on the middle relay has un-soldered from heat. Usually this relay is melted on one or two pins and could be replaced but taking the fuse panel apart isn't for the faint of heart.
